PAPERMILL POND DAM

CT. 00471

PHASE I INSPECTION REPORT
NATIONAL DAM INSPECTION PROGRAM

DECEMBER 1979

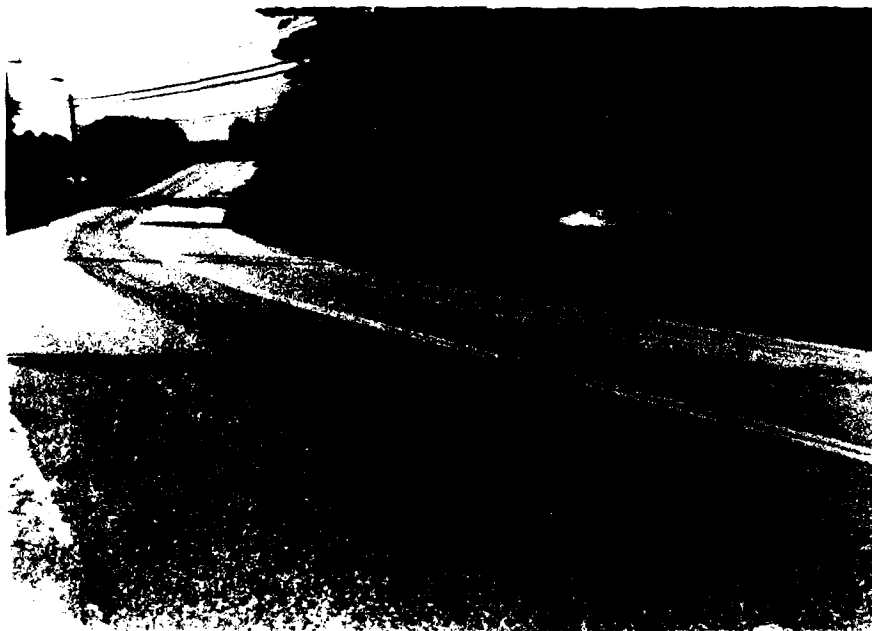
16. Bushnell Hill Road Bridge over the Little River

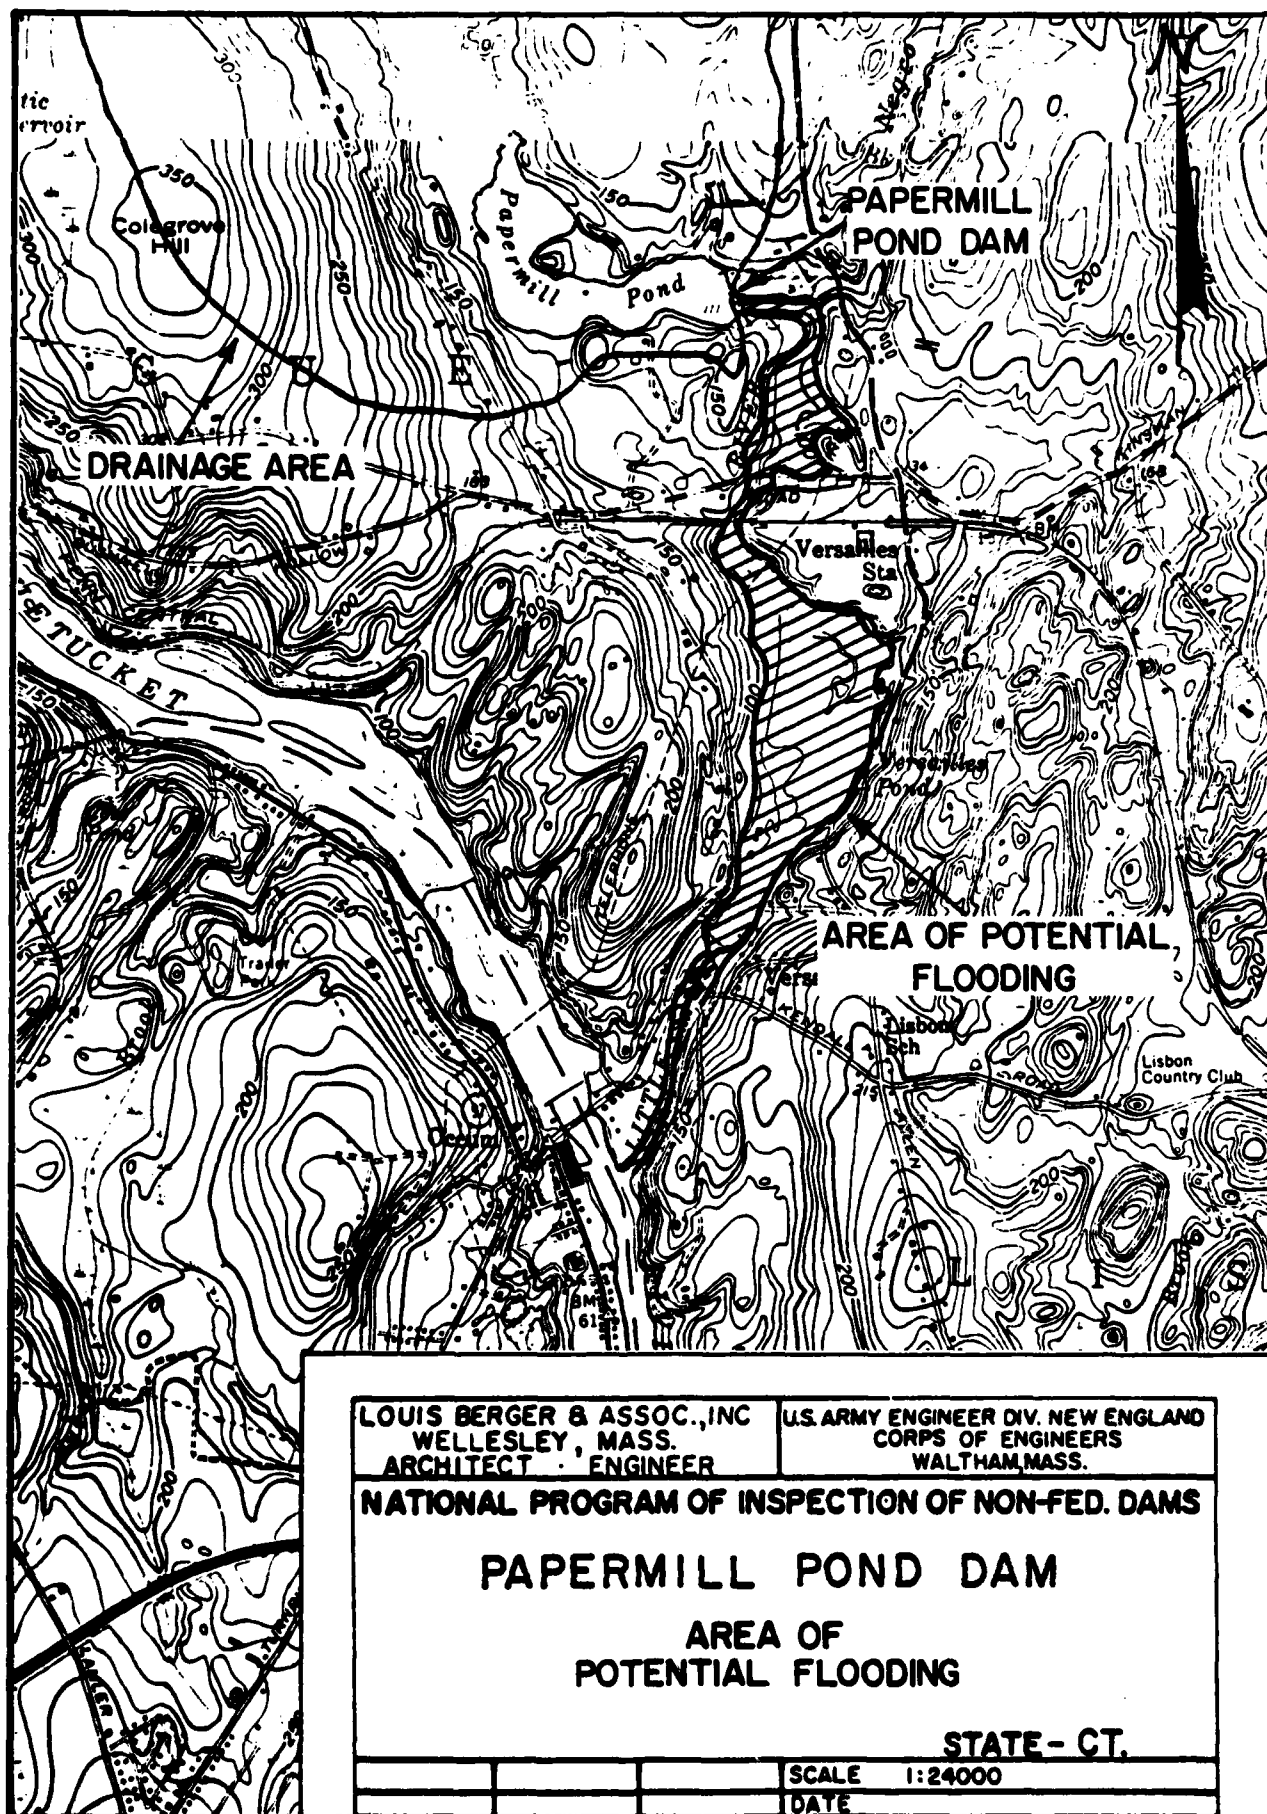
D-17

In summary, a breach of the dam could cause flood damage to two homes, two other buildings and a local road, and could cause damage to a railroad spur and an industrial building, with the possibility of the loss of a few lives. (Appendix D, Sheet No. D-17, shows the area of potential flooding.)
